538 SOUTHDALE ROAD EAST
LONDON, ONTARIO
TREE ASSESSMENT REPORT FOR ZBA

PREPARED BY: RON KOUDYS LANDSCAPE
ARCHITECTS INC

DATE: NOVEMBER, 2021

RKLA PROJECT #: 21-252

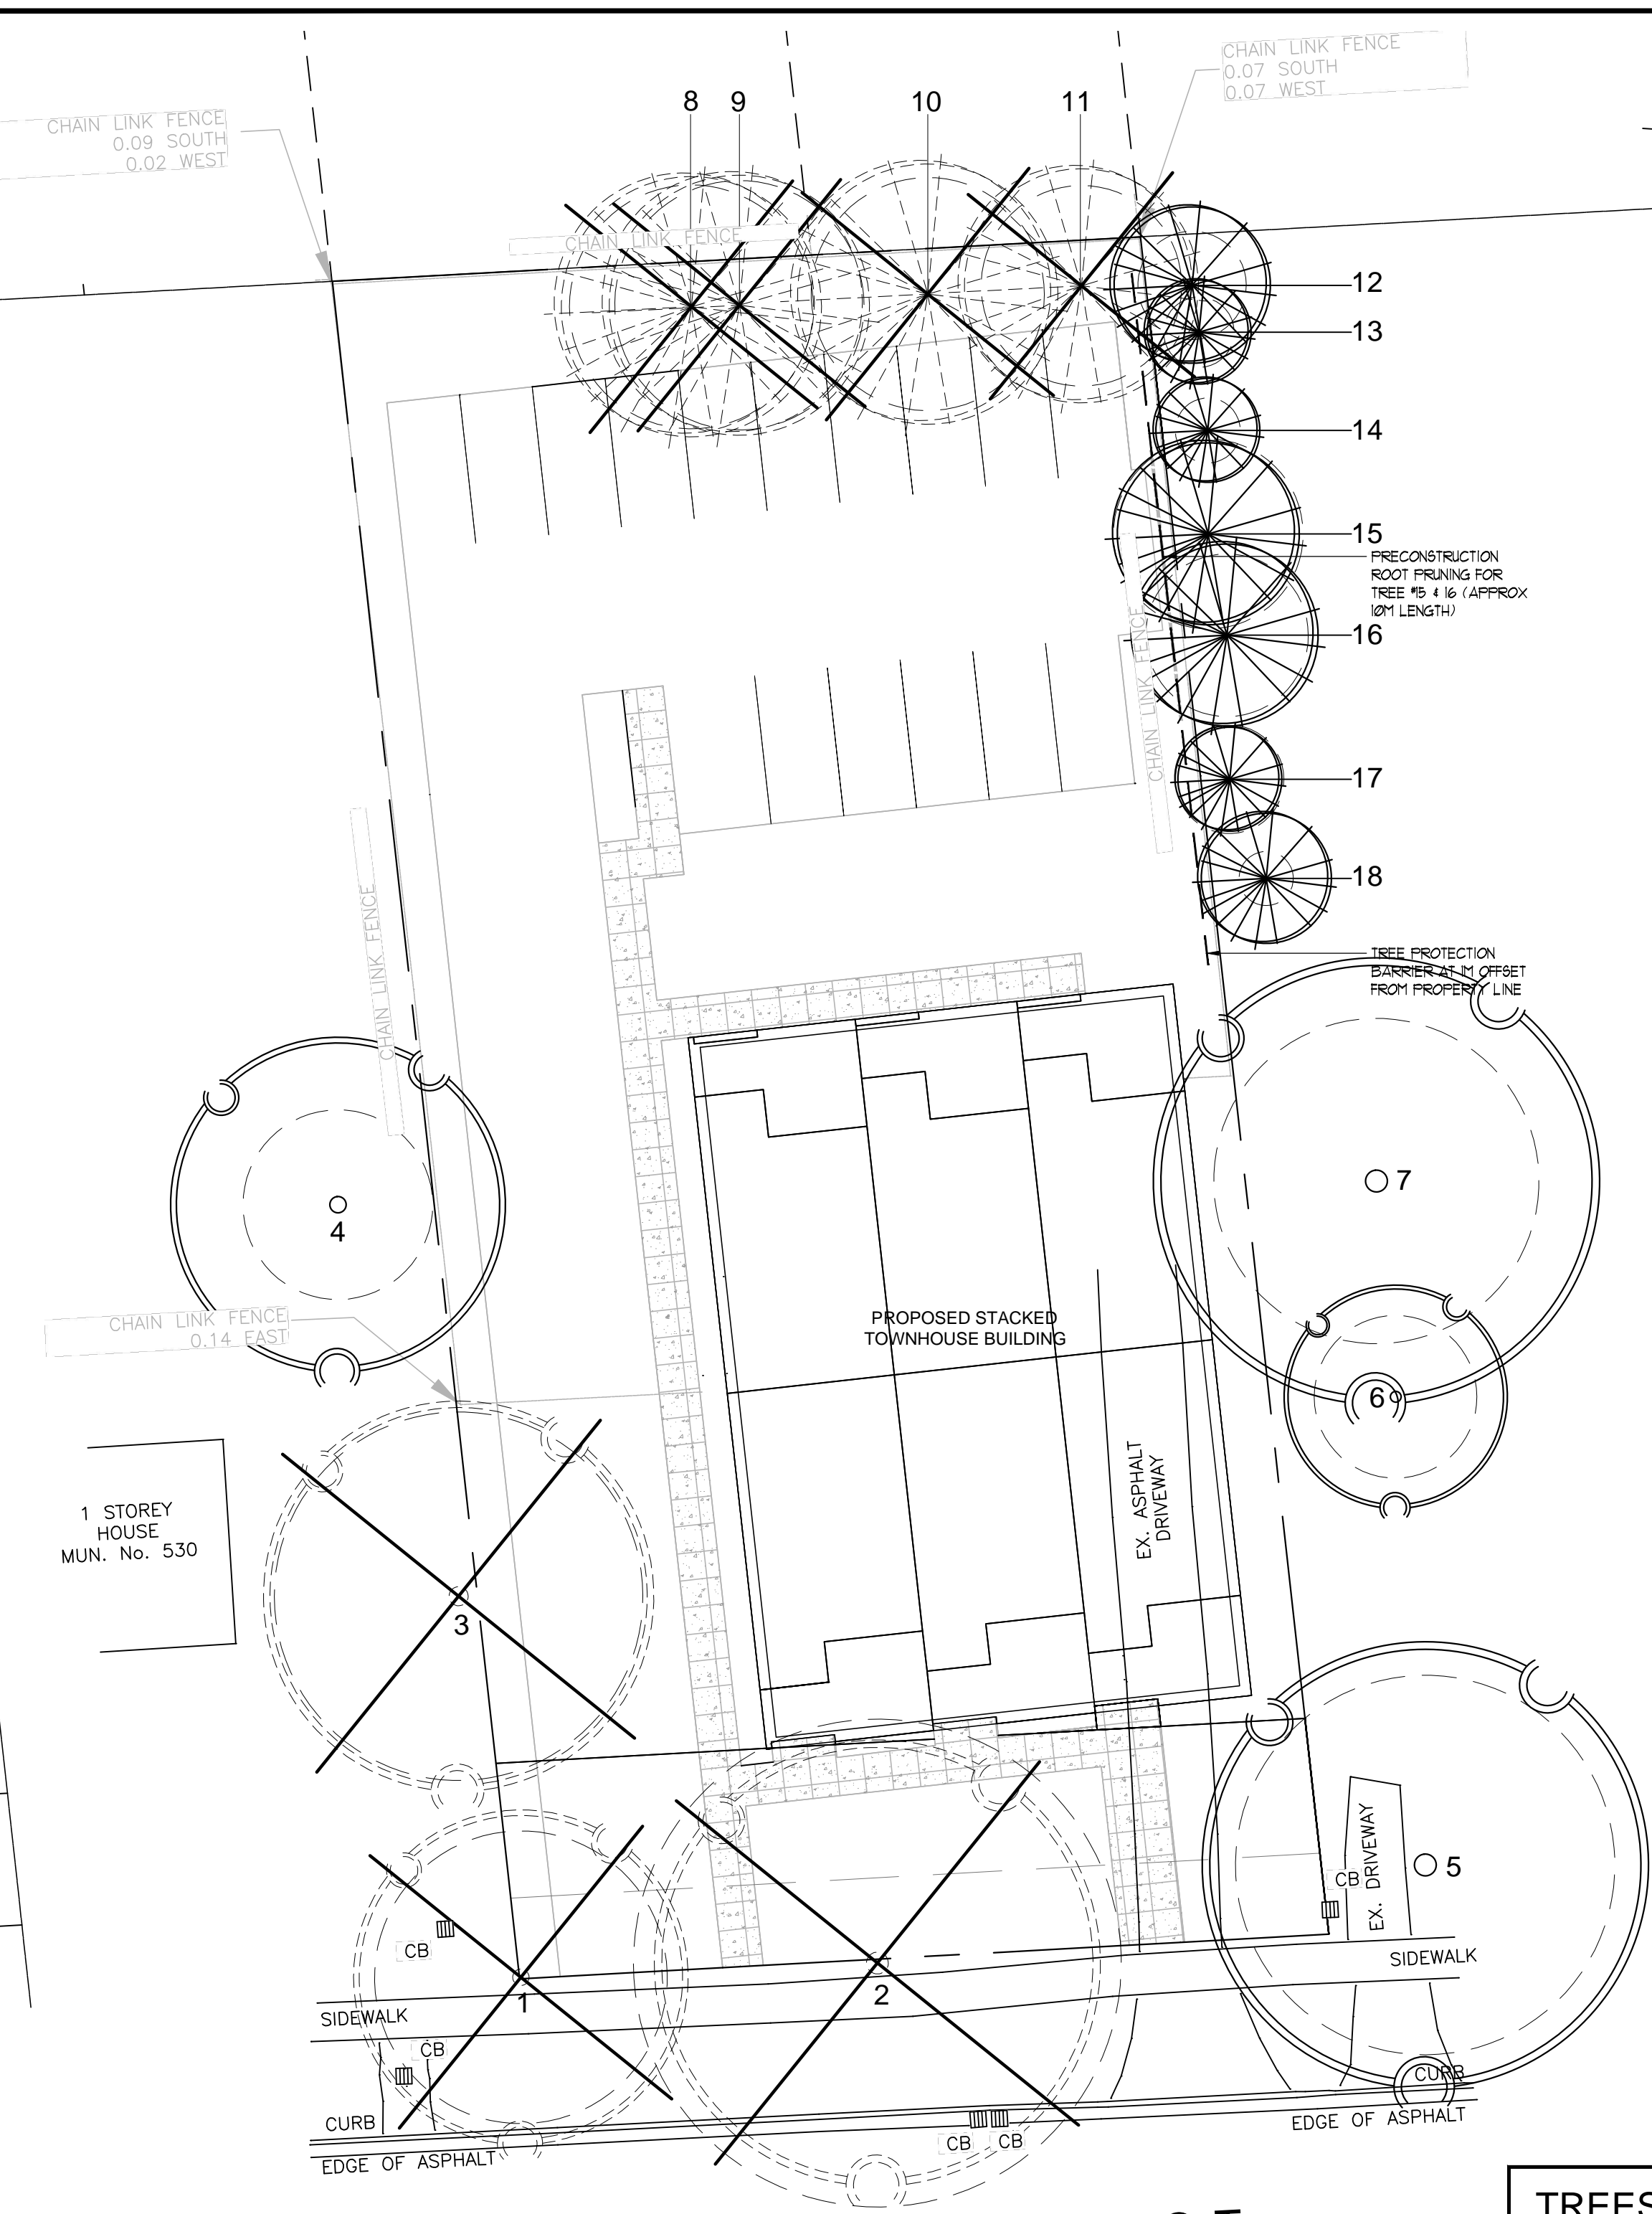
TREE PRESERVATION PLAN
SCALE = 1:200

TREE #'S 8, 9 & 11 HAVE BEEN RECOMMENDED FOR REMOVAL DUE TO POTENTIAL CONFLICT WITH SITE GRADING REQUIREMENTS. NOTE THAT THE INTENT IS TO COORDINATE WITH THE CIVIL ENGINEER AT THE TIME OF REFINED DESIGN FOR SITE PLAN APPROVAL TO LIMIT GRADING NEAR THESE TREES SO THAT THEY CAN BE PRESERVED.
